Impact of Solar Cell Cracks Caused During Potential Induced Degradation (PID) Tests

Mahmoud Dhimish, *Member, IEEE*, Jeff Kettle, *Member, IEEE*

Abstract— Potential-induced degradation (PID) of photovoltaic (PV) modules is one of the most severe types of degradation in modern modules, where power losses depend on the strength of the electric field, the temperature and relative humidity and the PV module materials. Understanding how module defects impact PID is key to reducing the issue. This work investigates the impact of cracks and fractural defects in solar cells and their impact on PID. We have tested using electroluminescence (EL) imaging how solar cells with varying levels of cracks/defects impact PID and our results indicate that such defects have a sizeable influence on the PID. We also confirmed the strong relationship between the size of the initial defect/crack and the presence of hotspots. As the crack (dark) area increased, there was a further increase in the cell's temperature under standard test conditions. In this work, it is observed that minor cracks in solar cells have no considerable PID effect for the solar cells providing some reassurance that quality contro

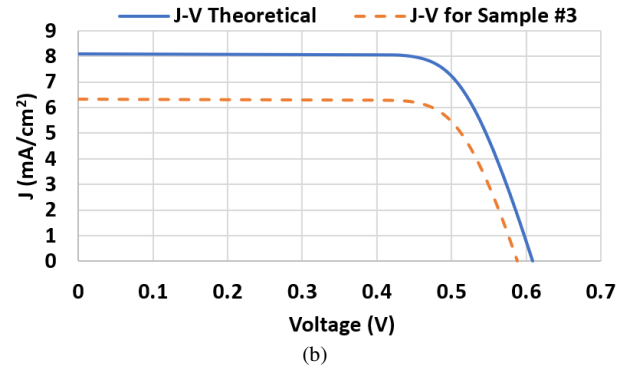
As the solar cell exhibits significant losses in the J_{sc} we have decided to test the cell under standard test conditions (illumination of 1000 W/m² and cell temperature 25 degrees), as shown in Fig. 11(a). The resultant current-voltage (J-V) curve compared with the theoretical values (taken from the solar cell datasheet) is shown in Fig. 11(b). The current density at short circuit conditions dropped by 20.5%, calculated using (1), whereas 4.9% was the drop in the V_{oc} calculated using (2). This concludes the fact that dark areas in EL images likely means that the cells are being impacted with severe PID.

$$\text{Drop in } J_{sc} = \frac{\text{Theoretical } J_{sc} - \text{Measured } J_{sc}}{\text{Theoretical } J_{sc}} \times 100 = \frac{38.1 - 30.3}{38.1} \times 100 = 20.5\% \quad (1)$$

$$\text{Drop in } V_{oc} = \frac{\text{Theoretical } V_{oc} - \text{Measured } V_{oc}}{\text{Theoretical } V_{oc}} \times 100 = \frac{0.61 - 0.58}{0.61} \times 100 = 4.9\% \quad (2)$$

Fig. 11. (a) The solar cell is exposed to 1000 W/m² illumination, (b) Measured J-V curve under STC conditions.
